CLASSIFICATION COMPLEMENT II Approved For Release 2006/08/08 P. A. RDP82-00457R010600380003 INTELLUENA 29 INFORMATION REPORT 25X1A CD NO. COUNTRY USSR ("stonian SSR) DATE DISTR. 25 Feb. 1952 Old Harbor in Tallinn SUBJECT NO. OF PAGES 25X1A PLACE NO. OF ENCLS. 1 (2 pages) **ACQUIRED** DATE OF SUPPLEMENT TO INFO. 25X1X 🗓 REPORT NO. THE DOCEMENT CONTROLLED BY MARTINES AFFECTION OF HATOMAL DEFENSE
OF THE CHIEF CONTROL WITH MARTINES AFFECTION OF THE HATOMAL DEFENSE
OF THE CHIEF THE WARD OF THE HATOMAL OF THE CHIEF THE APPLICATION OF THE APPLICATION THIS IS UNEVALUATED INFORMATION

- The Ild Harbor in Tallinn (59°26'N/24°U5'E) was the commercial harbor of Tallinn and was located on the eastern edge of and about 500 to 1,000 meters from the city, The commercial harbor was about 1,000 x 1,000 meters. It was formed by two moles. The noles and other harbor installations were thoroughly denolished during the war. The greater part of the destroyed places and installations had been reconstructed by February 1949. (1)

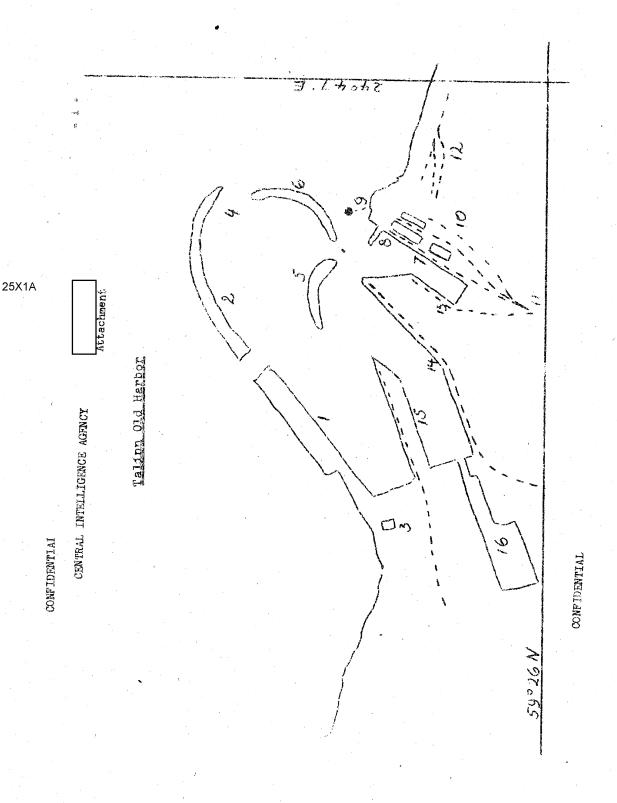
Attachment

- (1) A sketch was made from sea chart D 36 and the observations were entered. See annex.
- (2) The information on the construction of a new breakwater has not been confirmed. It night have been necessary to build this breakwater in order to break the swells prevailing in the harbor because of the northeasterly winds. However, it is also possible that only the bridge which leads to the sea light there was reconstructed.
